# Manhole Inspection Summary

Manhole # S17QQ1006MH

Insp Date: **11/14/06 3:39 PM**

**Location** Address: **5013 WOODLANDS GLEN RD**

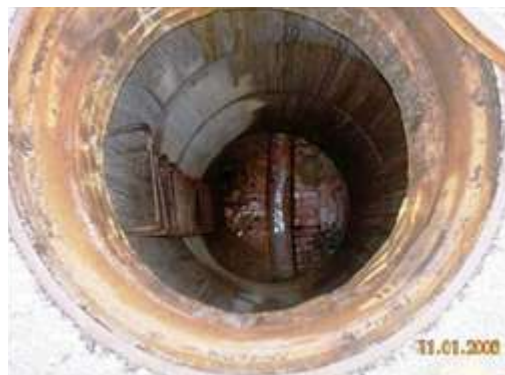
Top View

☒ **Debris** (not Condition related)

Count: **11** Missing: **0** ☒ **Corroded**

Corroded steps. Bench debris.

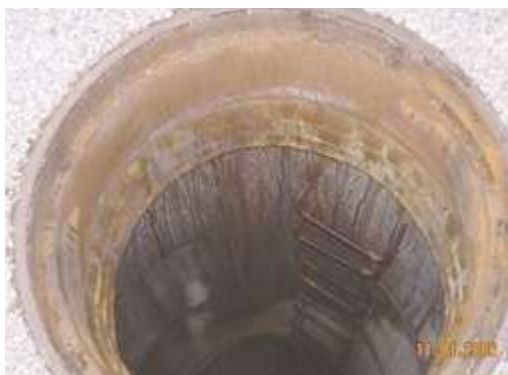
Defect

☒ **Leaks**

Infiltration: ☐ None ☒ **Joint** ☐ Cracks ☐ Mortar ☐ Roots ☒ **Wall**

Frame leaks. Adjustment infiltration.

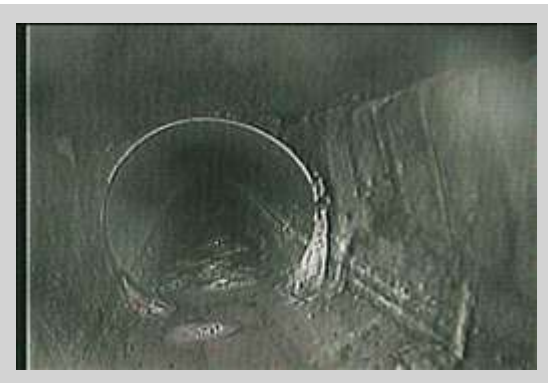
### 8 in. Circular Gravity Sewer Pipe In @ 6 O'Clock

Deposits: ☐ None ☐ Mud ☐ Sludge ☒ Debris ☒ Grease

Silt Depth: **0.5** (in.) Deposits Extent: **Light**
